Abstract

**The Test Boat
Absolute 50 Fly**

Report Log - Haul-Out & Inspection March 22, 2022

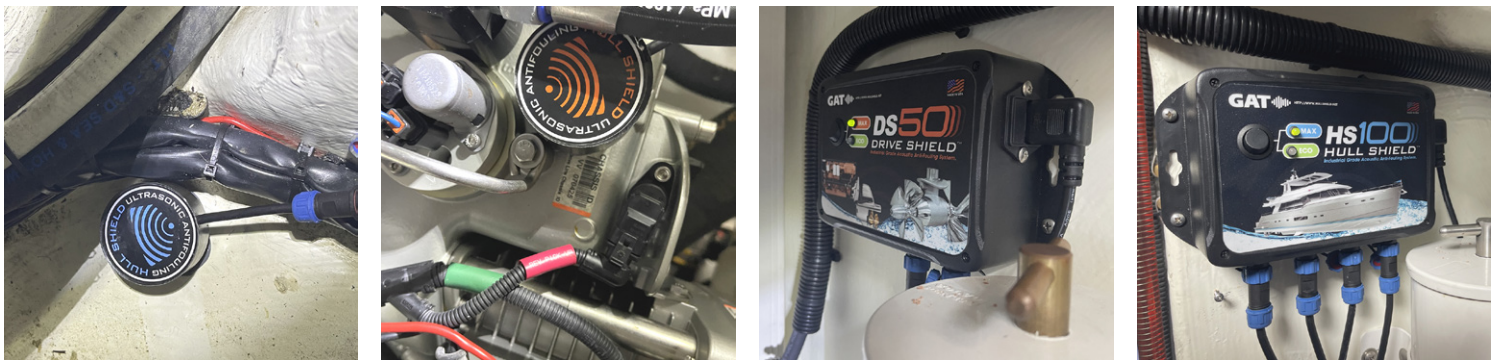
Report Log - Installation March 13, 2021

On March 13, 2021 Hull Shield Ultrasonic systems were installed on the Absolute 50 Fly at the test location in Charleston, South Carolina. A single HS100 4-transducer system was installed to provide anti-fouling protection for the hull. The two pod drivers were protected with a single transducer per-drive, powered by a DS50 Drive Shield anti-fouling system.

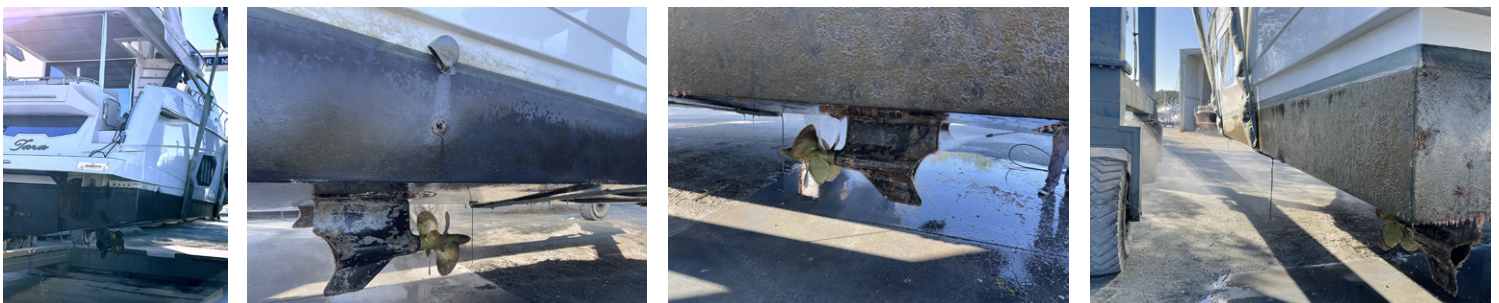
After 53 weeks in the water with no bottom cleaning maintenance, the Absolute 50 Fly had no signs of increased drag, loss of top-end speed, or inefficient operation. On March 22, 2022, the boat was hauled for routine scheduled maintenance which revealed that the hull and drives were very clean, having very little soft fouling and absolutely no hard fouling or barnacles.
