## Abstract

The GAT Group has collaborated with Bennington boats, a subsidiary of Polaris, to test the efficacy of the Hull Shield ultrasonic driver system when installed on aluminum pontoons. Aluminum boat owners have limited bottom paint options due to the galvanic corrosion resulting from a primary anti-fouling used in bottom paint - copper oxide. This study implemented multiple test configurations to determine optimal design and installation practices of the Hull Shield HS75 system such as transducer placement, frequency response, and power configurations.

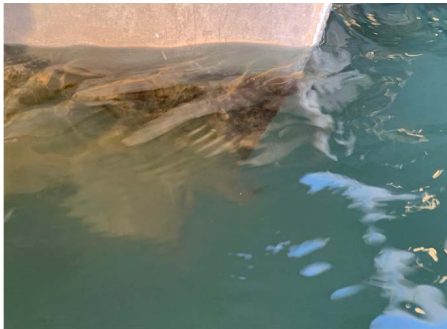
Day 14 Result - Unprotected Pontoon

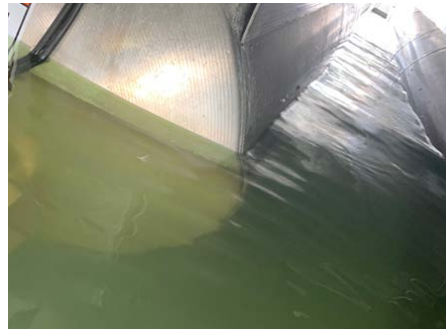
Day 14 Result - Pontoon with Hull Shield HS75

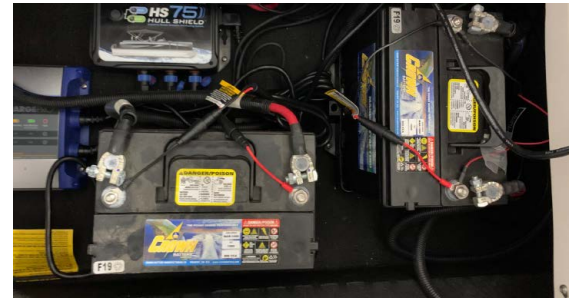
Hull Shield HS75 ultrasonic unit installed in the test boat.

The Hull Shield HS75 test unit was installed on December 3, 2019 at the Bennington manufacturing plant in Elkhart, Indiana. Hull Shield ultrasonic transducers were mounted to all three pontoons - each at different locations. The control module (shown at right) was conveniently mounted inside the battery compartment.

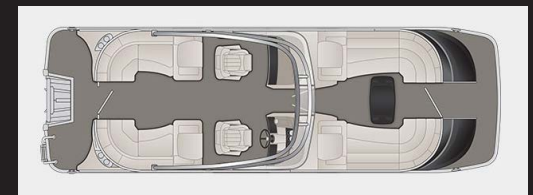
Floor plan of 25QXFB (Source: benningtonmarine.com)

Bennington provided a 25QX series luxury tritoon for testing in Palm Beach, Florida. The test boat has an LOA of 27' 3" and features a triple pontoon design.

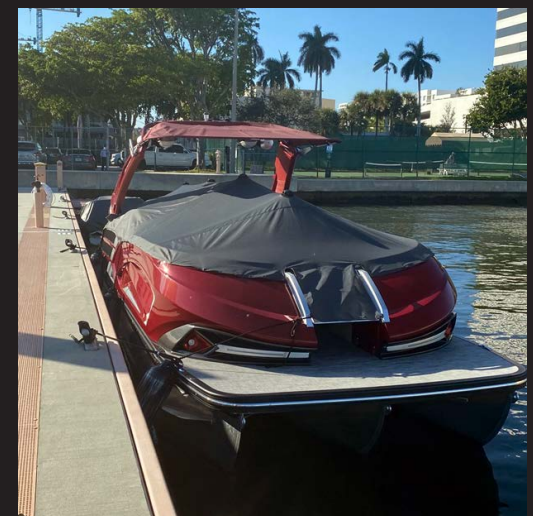
Photograph of the test boat docked in Palm Harbor Marina on January 7th 2020 (Source: GAT Group).

The Bennington 25QX is docked at Palm Harbor Marina and remains parked for the duration of the study. The site is periodically visited to document the fouling growth rates on the submerged pontoon surfaces.

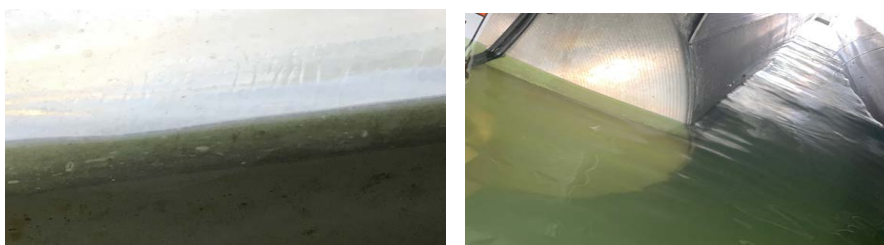
Photos taken on January 22, 2020 after 14 days of relatively no fouling accumulation.

The test site was again visited on January 22, 2020 to document growth accumulation. Minimal growth had occurred during this time - the Hull Shield system had been active for a total of fourteen (14) days.
